# Property Condition Assessment & Capital Planning

## **Old Forest Arena 6276 Townsend Line, Forest, Ontario**

Prepared for:  
**Municipality of Lambton Shores  
7883 Amtelecom Parkway  
Forest, Ontario  
N0N 1J0**

November 24, 2021  
IRC LB21-046 CR-24363

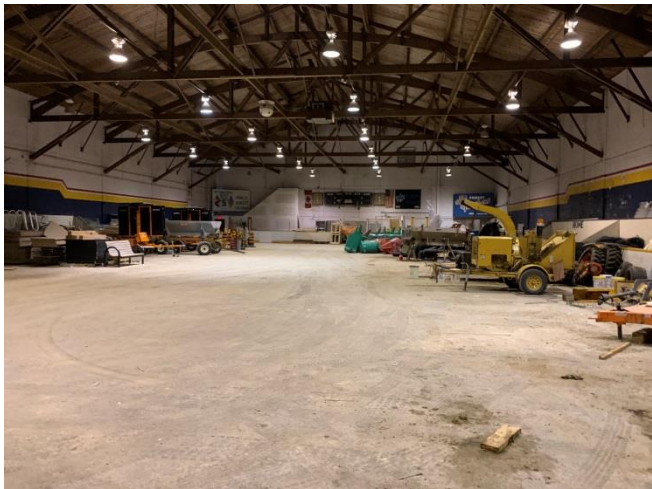
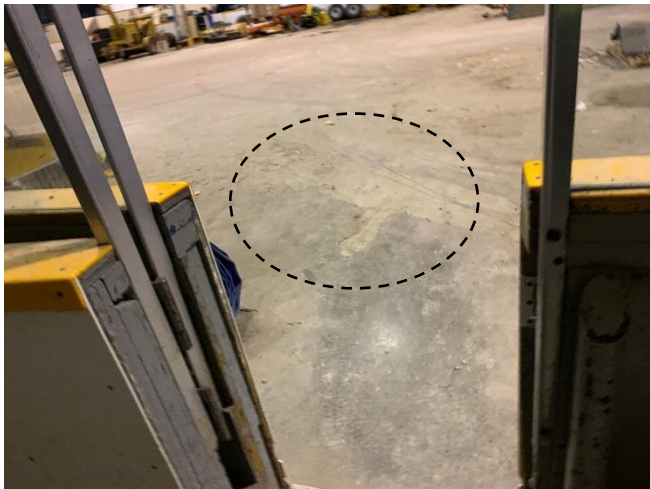
| Observations & Recommendations | |
|---|---|
| <ul style="list-style-type: none"> <li>- The concrete slab-on-grade in the arena was noted to be in poor condition with areas of cracking and evidence settlement noted throughout.</li> <li>- It was reported that some exterior doors at the arena do not open and scrape the floor due to settlement.</li> <li>- The concrete slab-on-grade was only visible at the arena. All other areas were concealed under floor finishes.</li> <li>- Due to concealed nature of the footings their condition could not be determined.</li> <li>- A preliminary repair allowance of \$35,000 has been carried within the early portion of the term of analysis for the repair of the slab-on-grade. Actual cost will be determined once the floor finishes are demolished.</li> <li>- Continued review and assessment of the structural components should be completed as part of an annual review and regular Property Condition Assessment.</li> </ul> | |

| Photographs | |
|---|---|
| <p>Interior view of the concrete slab-on-grade at the arena.</p> | <p>Deteriorated concrete slab-on-grade at the arena.</p> |

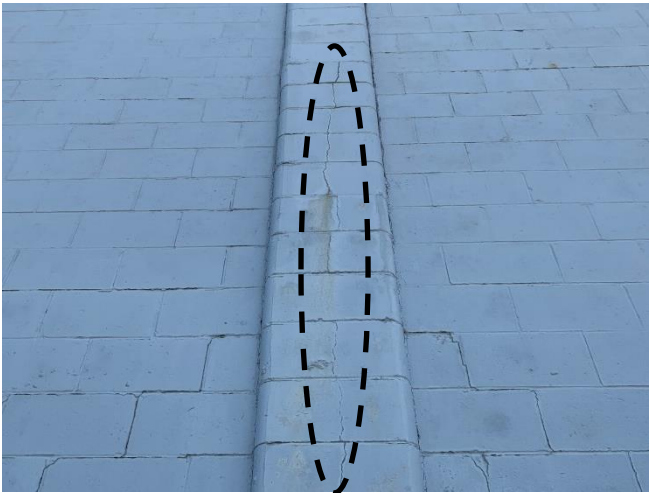
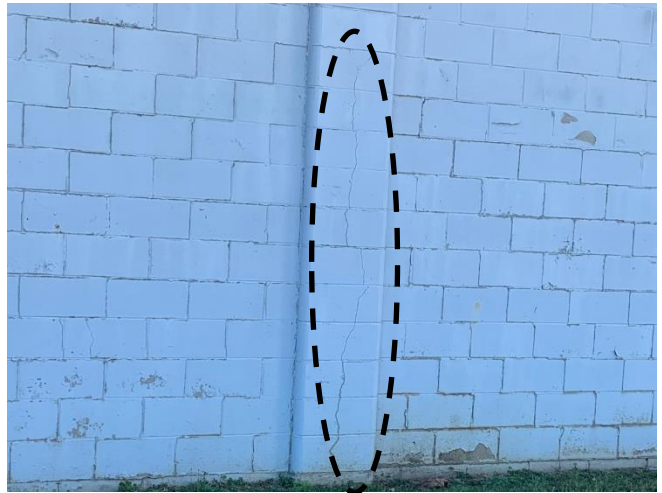
| Observations & Recommendations | |
|---|---|
| <b>B1010.00 Superstructure - Support Columns</b> | <ul style="list-style-type: none"> <li>- Areas of vertical cracking were noted on the concrete block masonry columns.</li> <li>- IRC recommends a detailed structural review of the loadbearing structural elements to be completed by a qualified structural engineer prior to any repair work.</li> <li>- A preliminary repair allowance of \$225,000 has been carried within the early portion of the term of analysis for the repair of the support columns. Actual cost will depend on the outcome of detailed investigation.</li> <li>- Continued review and assessment of the structural components should be completed as part of an annual review and regular Property Condition Assessment.</li> </ul> |

Vertical cracks on the exterior face of a support column.

- Visual exterior review of the support columns at the arena exhibited signs of vertical cracks through the concrete block masonry. IRC recommends that these columns be reviewed by a structural engineer prior to repair work (see section 1010.00) of this report.

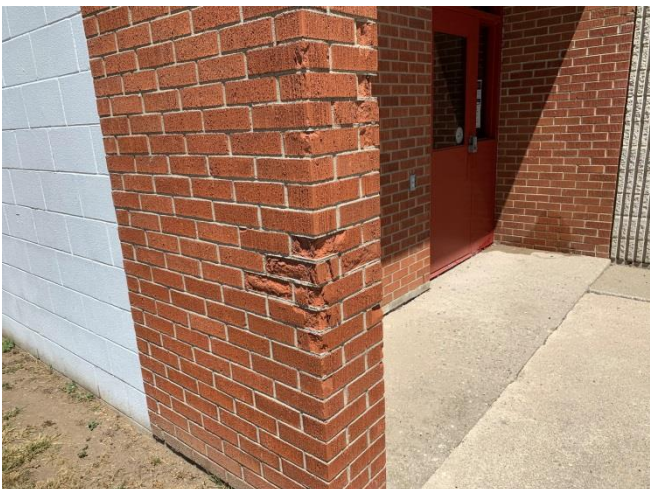
| Observations & Recommendations | |
|---|---|
| <b>B2010.01 Exterior Walls - Brick Masonry</b> | <ul style="list-style-type: none"> <li>- Brick masonry is located on the south, southeast and southwest elevations of the building.</li> <li>- Cracked and spalled brick masonry units were noted during the review.</li> <li>- Review of the construction drawings indicated that the brick masonry walls were added to the Building in 1961 (~ 60 years ago).</li> <li>- Mortar joint deterioration was noted at the junction of the brick and concrete block masonry.</li> <li>- An area of moisture staining was also noted on the south elevation.</li> <li>- A repair allowance has been carried within the early portion of the term of analysis. It is noted that this allowance is for the exterior brick only and excludes the brick masonry noted within the interior walls of the room on the southwest portion of the building.</li> </ul> |

Deteriorated brick masonry units noted on the south elevation.

- The brick masonry of the exterior walls on the south elevation was noted to be in poor condition. Allowance for repairs has been carried in 2 – 5 years.

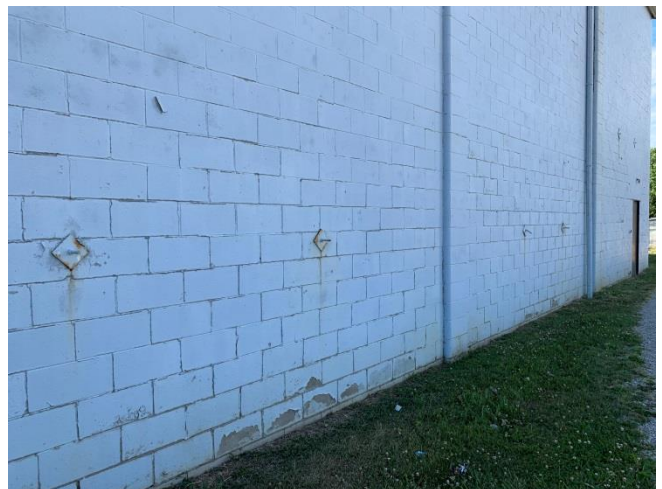
| Observations & Recommendations | |
|---|---|
| <b>B2010.03</b> | <b>Exterior Walls - Concrete Block Masonry</b> <ul style="list-style-type: none"> <li>- This item accounts of the concrete block masonry on the exterior walls.</li> <li>- The concrete block masonry was noted to be in poor condition on the east elevation with cracked masonry units and cracked mortar noted throughout.</li> <li>- Areas of moisture damage were noted on the northwest elevation which appears that this may be related to leaking eavestroughs. It is recommended that all downspouts are reviewed during rainfall to ensure downspouts don't leak onto masonry and direct water away from block masonry.</li> <li>- A budgetary allowance has been allocated for general block masonry repairs.</li> </ul> |

Deteriorated concrete blocks and mortar joints noted.

- Cracked concrete block masonry and deteriorated mortar joints were noted on the exterior walls. Repair allowance has been carried within the 0 – 2 years.

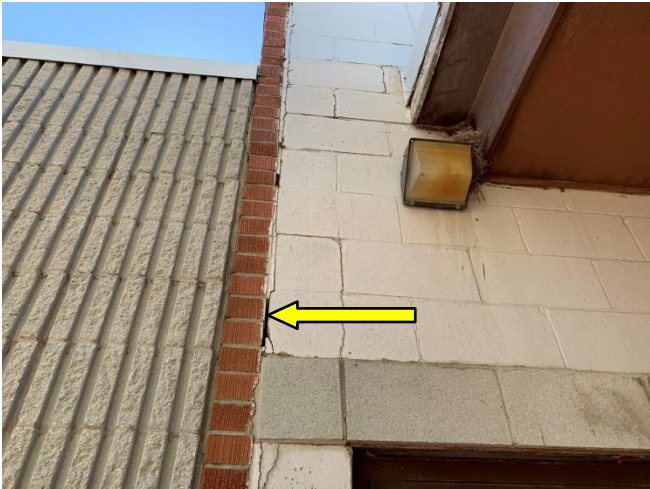
Mortar joint deterioration at the junction brick concrete block masonry.

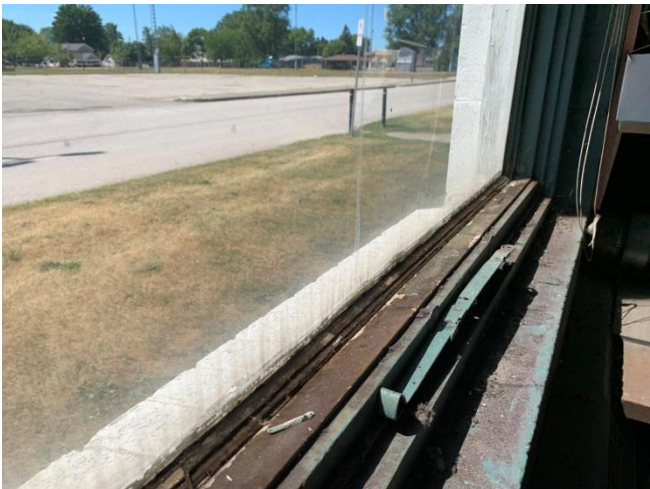
Interior view of a deteriorated window of the building.

- Allowance to replace windows and emergency exit doors have been carried in 0 – 2 years.
- Main entrance doors were old but functional, replacement is anticipated within 5 – 10 years.

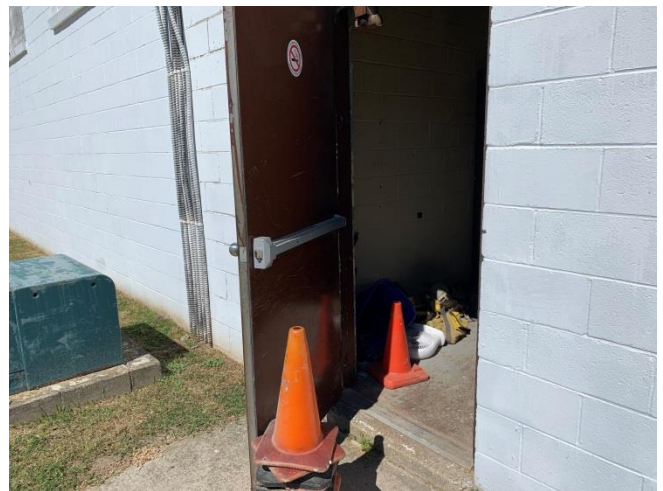
Emergency exit doors were noted to be old.

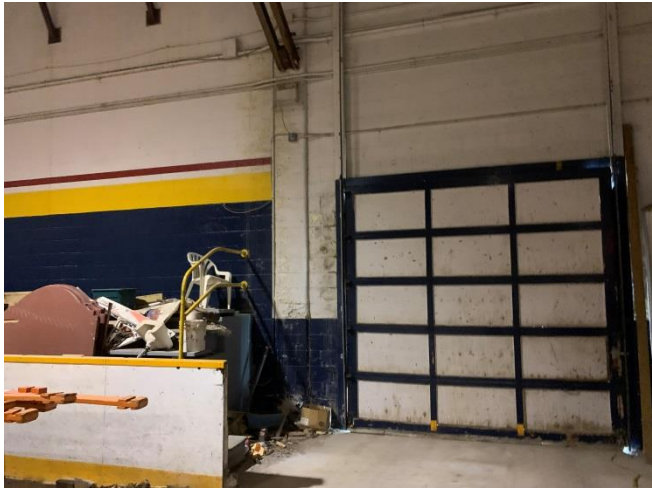
Wood overhead drive-in door on the northwest elevation was noted to be in poor condition.

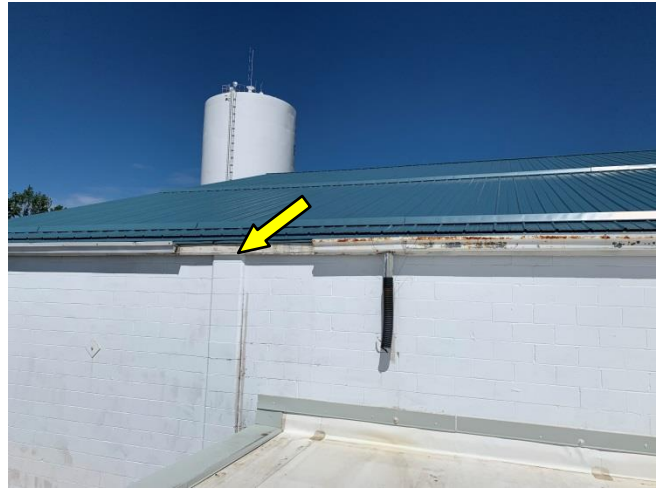
The sloped metal roof was noted to be in fair to good condition.

Note: Missing section of eavestrough was noted.

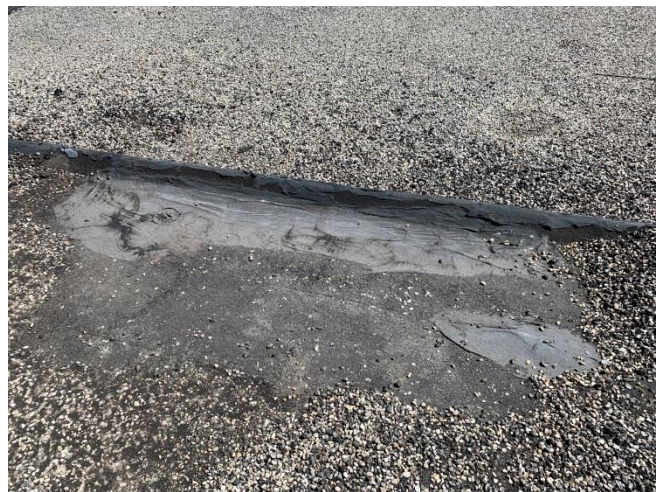
A repair patch on the BUR system.

- The Built-Up asphalt Roof (BUR) system on the south roof has surpassed its useful life. Replacement is anticipated within 0 – 2 years.
- Eave troughs were noted to be missing sections and were leaking. Replacement is anticipated in 0 – 2 years.

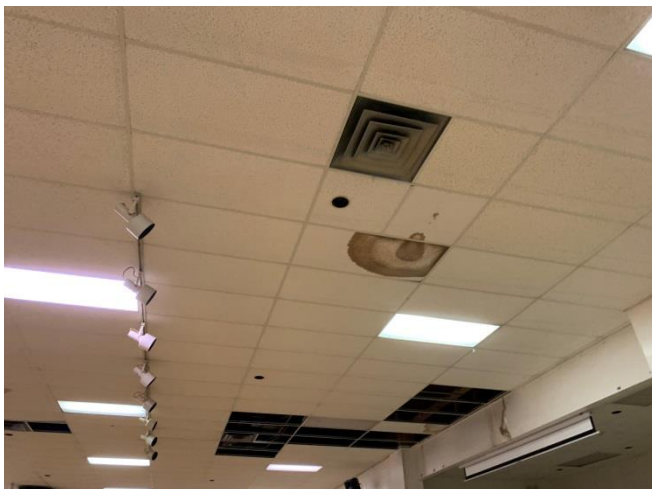
Leak staining noted on the ceiling beneath the BUR system.

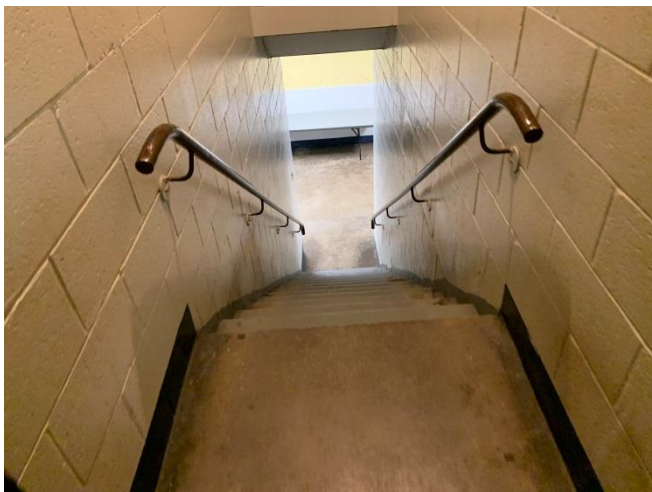
Stairs to the mezzanine level were noted in poor condition.

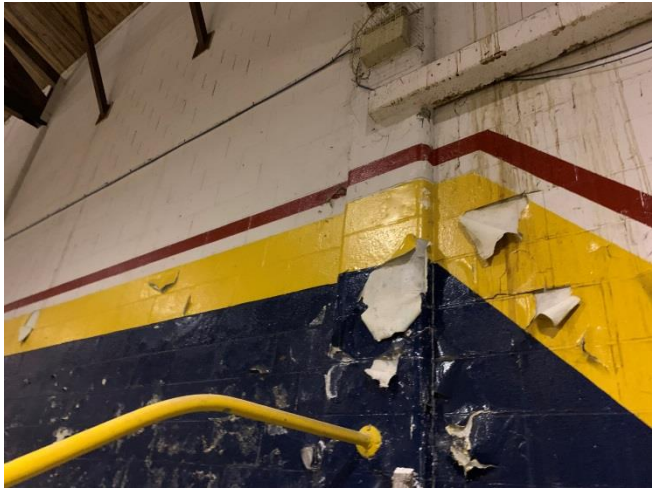
Interior walls were noted to be in need of painting.

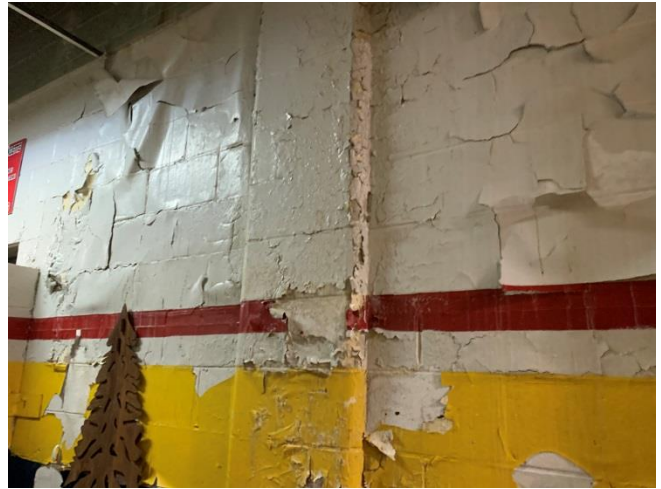
Deteriorated paint on the interior walls of a locker room.

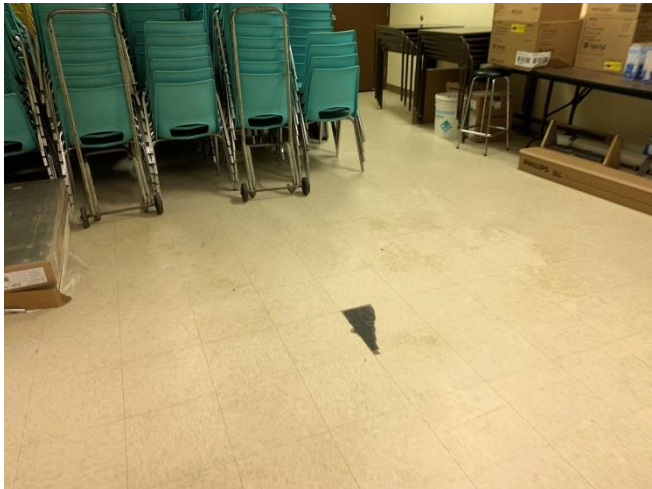
Damaged flooring within a storage room on the south portion of the building.

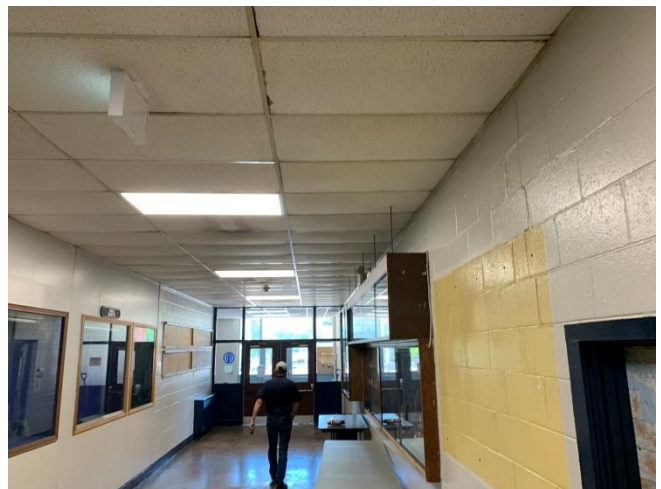
- Acoustic Ceiling Tiles (ACT) were noted at the community hall, corridors and rooms of the south portion.
- The ACT was noted to be in poor condition with areas of moisture damage and missing tile noted throughout.
- This item accounts for replacement of acoustic ceiling tiles and panel. The replacement anticipated to follow roof replacement, as the damages are attributed to roof leaks.

Ceiling tiles at the main entrance corridor were noted in poor condition.

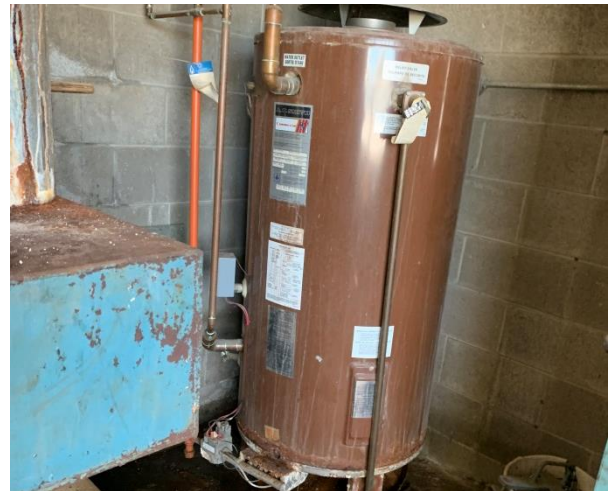
Old DHW heater tank within the boiler room.

- The DHW heater in the mechanical room was noted in poor condition. Replacement is anticipated within 0 – 2 years. Replacement of associated piping is also recommended.

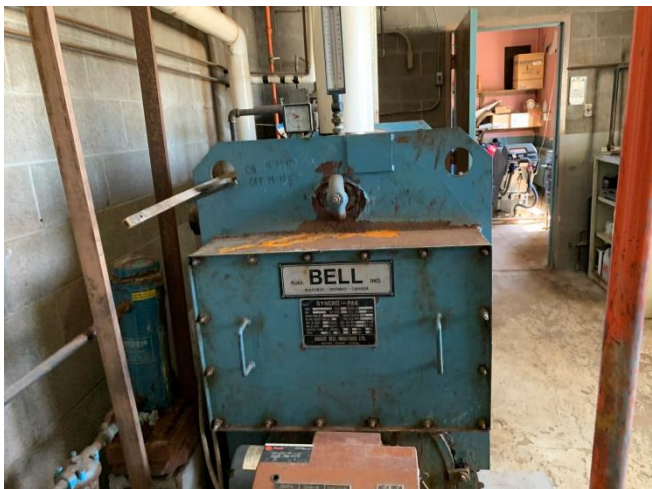
Old heating boiler in the mechanical room.

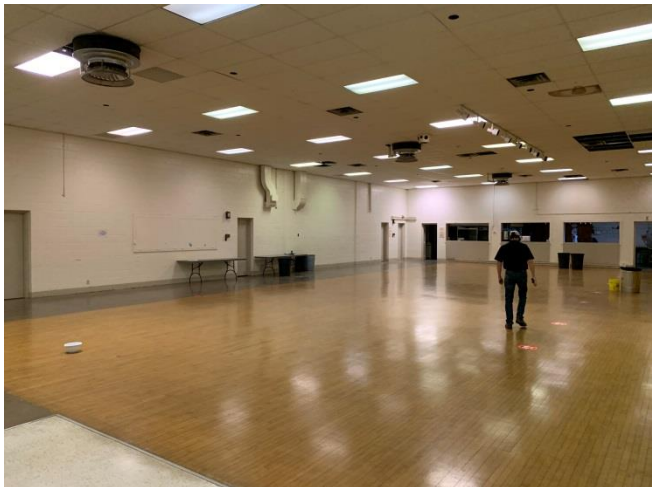
T12 lights were noted within the community hall.

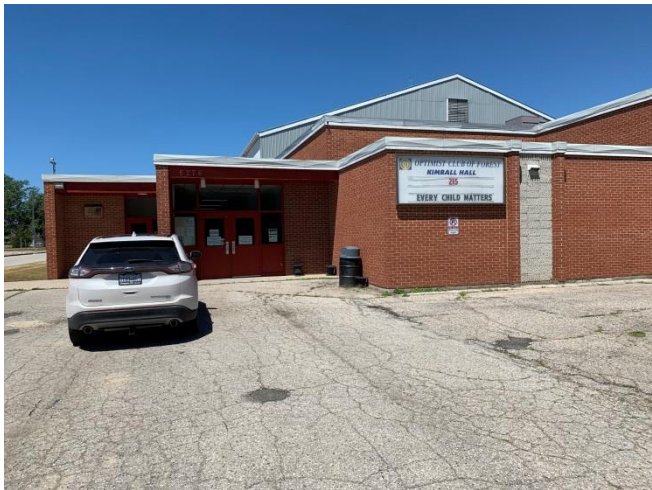
Deteriorated asphalt pavement on the south portion of the site.

- Asphalt paving and concrete curbs were noted to be in poor condition during the site assessment. Replacement and repairs are anticipated within the 0 – 2 years.

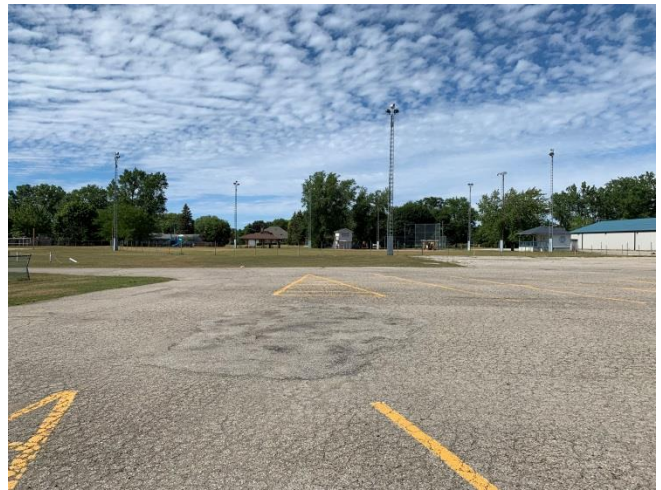
Deteriorated asphalt pavement on the east portion of the site.

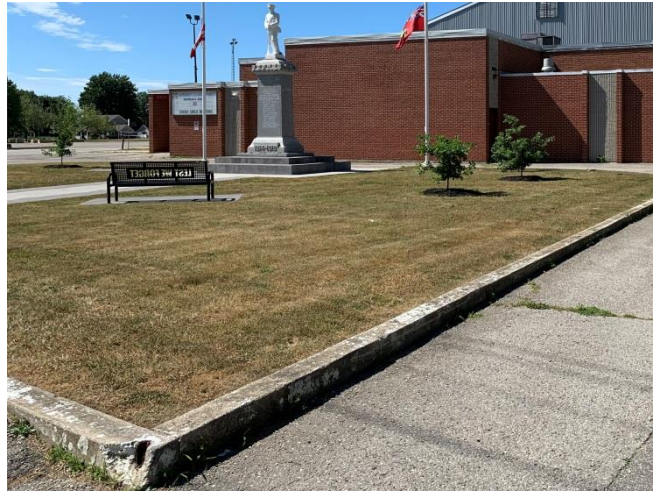
Deteriorated concrete curbs and monuments on the south portion of the site.
